A Grinding Solution

A customer had a problem using their existing gears in a new application. Ontario Drive & Gear provided the solution. Here's how they did it.

By John Donkers

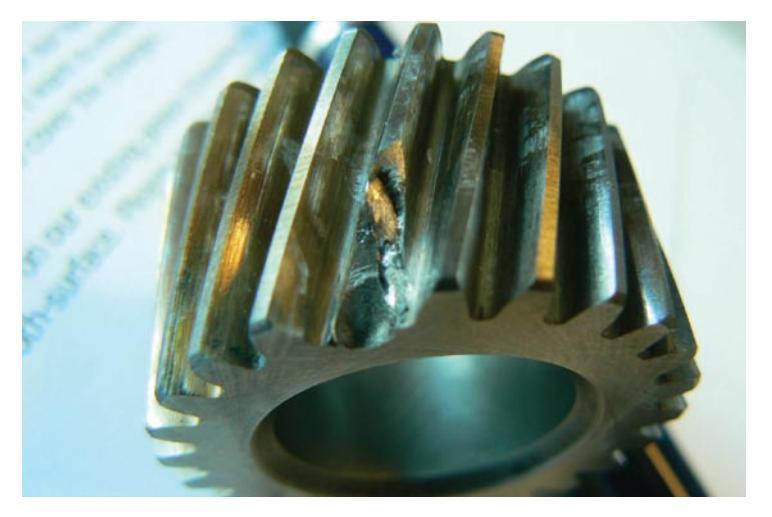
A company approached Ontario Drive & Gear (ODG) concerning a problem they were experiencing with a gear set used in a new application. It was found in a speed-increasing drive for an "under the hood" air compressor application, traditionally coupled to a six-cylinder engine. The company had been using them for years without any problems, but due to the recent economic downturn they where forced to seek new applications to increase sales. The customer decided to put these speed-increasing drives into trucks sold in Europe that were equipped with four-cylinder diesel engines. In this new application they began experiencing gear failure after only 20 hours, as shown in fig 1.

Fig. 1: The customer's gears were failing after only 20 hours in service.

Upon investigation of the failed parts it was evident that there were teeth breaking, as well as micropitting found on the gear tooth flanks. There was evidence of a low cycle bending fatigue failure, as the fracture surface was smooth and had distinct "beach marks" and "ratchet marks" showing the starting point of the crack. The gear tooth was broken on the large chamfer side of the gear, where it butts against the bearing side of the shaft.

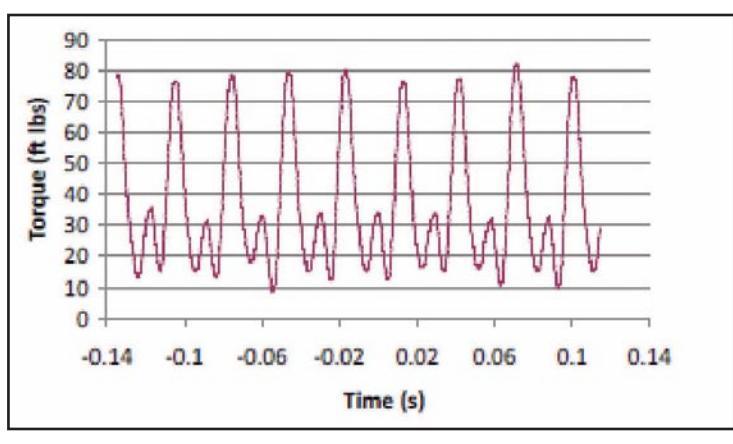
With some testing using equipment to monitor the torque levels, the customer was able to plot the torque vs. time, as seen in fig. 2. This highlighted the point where there was a significant torque spike coming from the engine that wasn't apparent in the six-cylinder gas engine. The operational parameters were as follows:

Fig. 2: The customer was able to plot the torque vs. time.

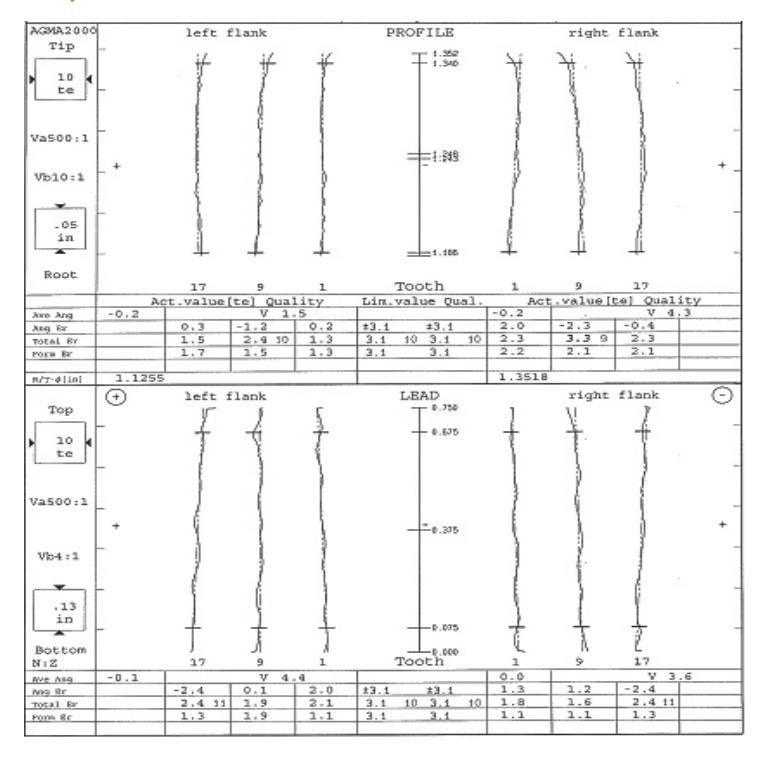
Fig. 3: Original 24T pinion lead and profile chart.

Since this customer didn't have complete information on the gear set in terms of root radius lead crowning or profile crowning, we reverse engineered the parts to provide details on what the parts looked like at a micro level. Since ODG is a member of Ohio State University's Gear Consortium, we have access to the powerful gear software Windows LDP (Load Distribution Program), which allowed us to fully model the gear by reverse engineering the parts, taking various measurements as well as inspecting the gear teeth with our dedicated CNC gear inspection equipment. The inspection results enabled us to model the gear in LDP. Although these gears were of good quality, it was apparent that they did not have any micro geometry modification, in terms of lead and or profile modifications (fig. 3).

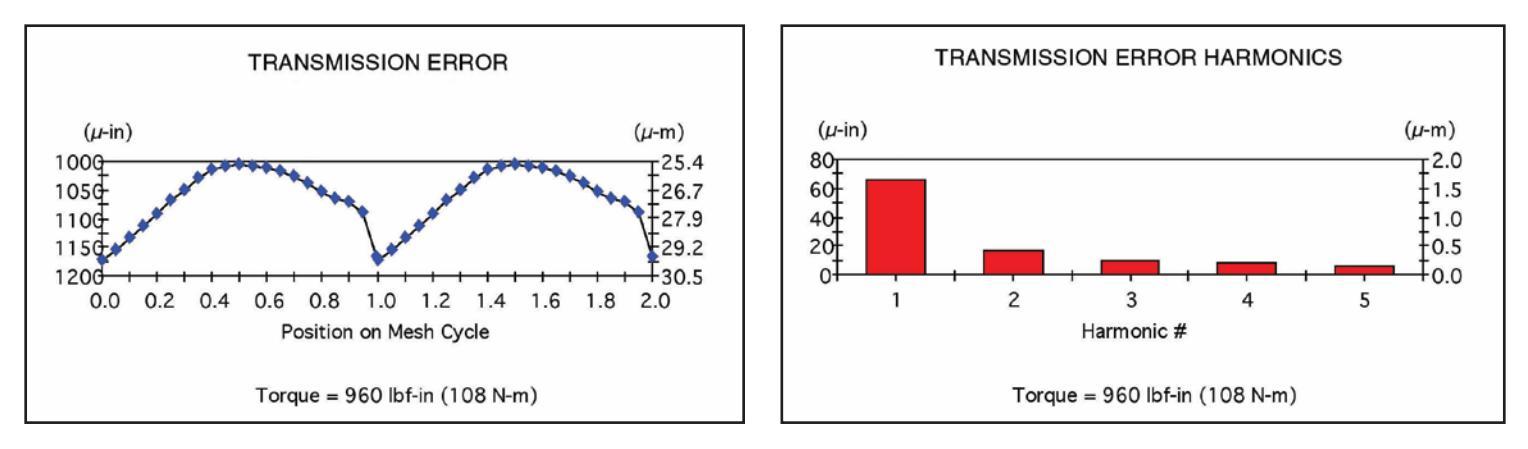
Fig. 6: Peak to peak transmission error was 166.54 micro inch (left). Harmonic transmission errors where 65.4 micro inch for the first harmonic and 16.8 micro inch for the second harmonic (right).

It was evident with this analysis that since the gears where misaligned during operation they where failing due to the excessive stress in the root of the tooth as well as on the gear flanks. For gear noise we look to LDP to establish the baseline of this design. We primarily look at the transmission error plots that LDP outputs, and then use this baseline to try and create a new and improved design. Figure 6 shows the baseline plot from LDP using the peak torque value and 0.15 degrees of misalignment (fig. 6).

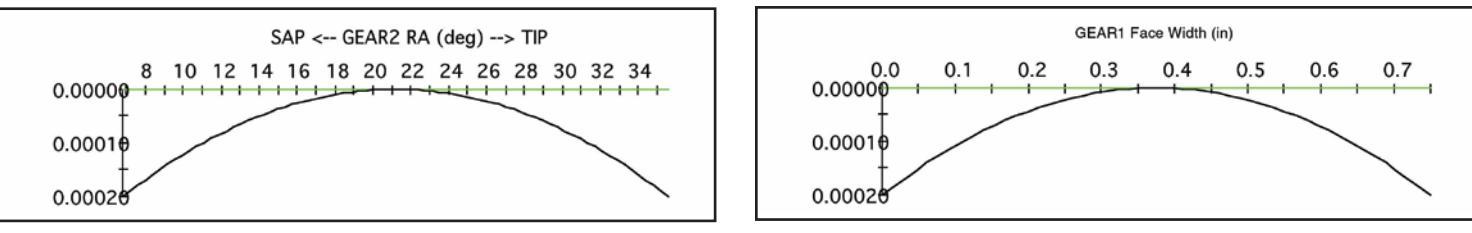
Fig. 7: Profile crown chart at left, and lead crown chart at right.

With this new gear set modeled in LDP we were able to look at what adjustment we could make to the micro-geometry that would optimize the contact area and the control of stresses in root of the tooth, as well as control the transmission error that causes gear noise. The lead control and profile control charts in fig. 7 are the result of numerous "trial and error" procedures involving different

micro-geometry adjustments we made to the design of the gear set. We came up with .0002" lead crown and a .0002" profile crown chart on both the pinion and the gear.

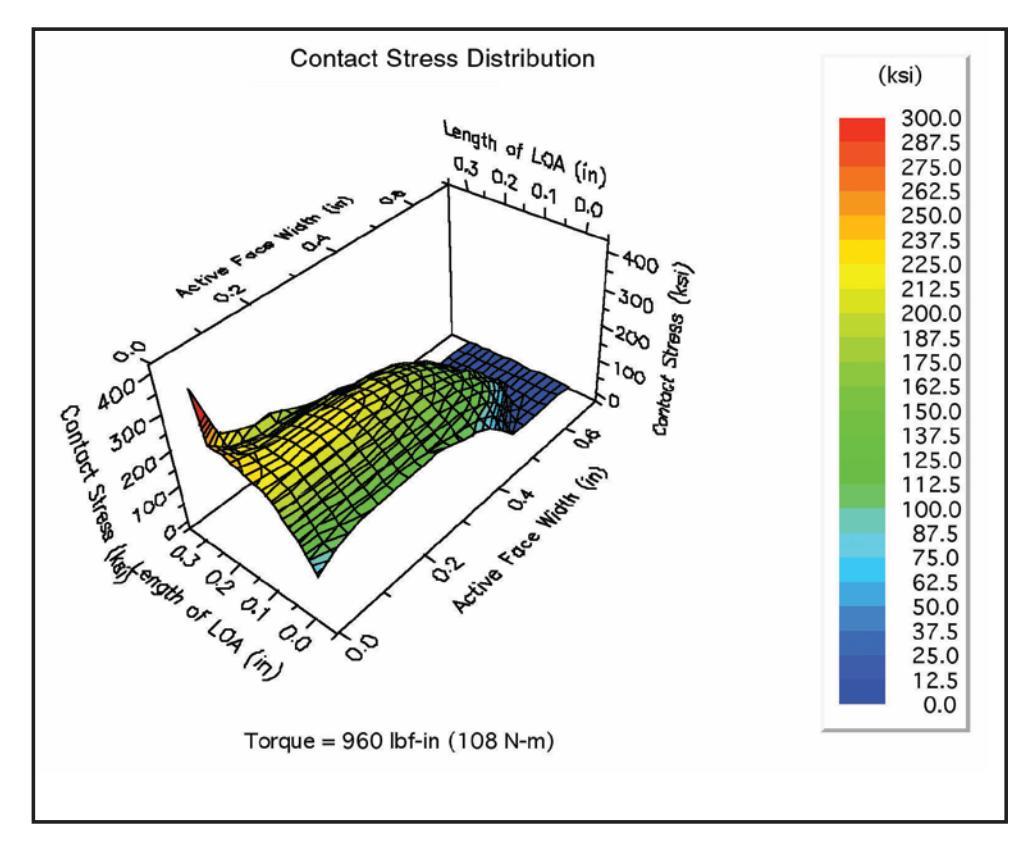
Fig. 9: Contact stress is more evenly distributed over more of the width of the gear, with a peak stress of 234 KSI.

With the lead and profile modifications we were able to control the location and amount of bending and contact stress. Figure 8 shows the bending stress on the pinion, with a much lower stress than before. The stress dropped from 188 KSI to 75 KSI, which is 40 percent of the original bending stress, and it is also located in the middle of the tooth rather than on the end. Next we looked at the transmission error plots to make sure they were as good, or better. The result was that the peak-to-peak transmission error was 41 percent compared to the original design.

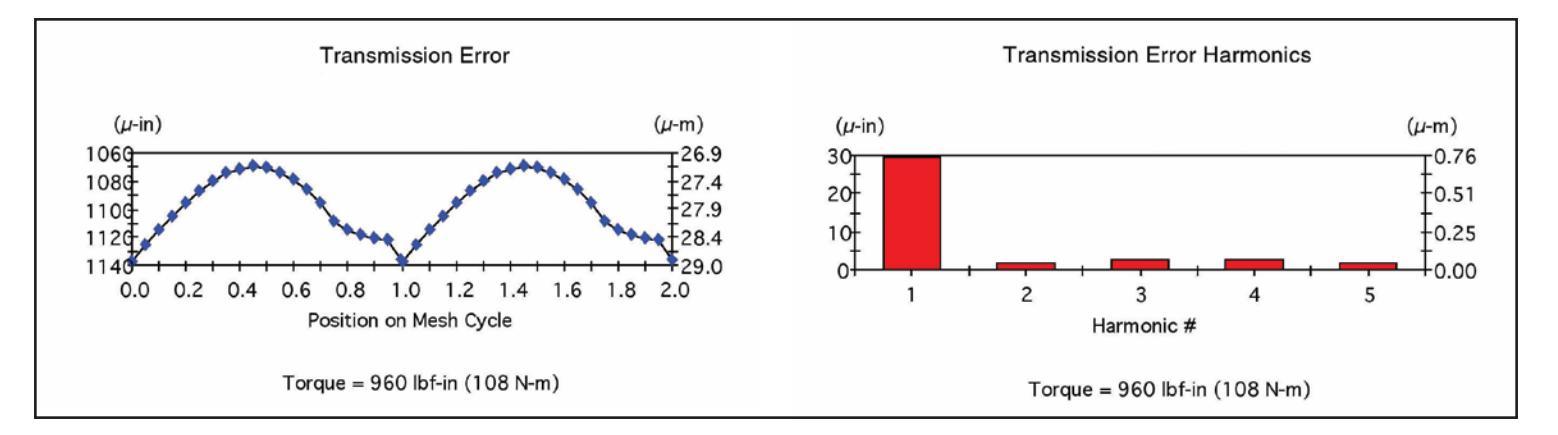
Fig. 10: Peak-to-peak transmission error was 68.1 micro inch (left). Harmonic transmission errors where 29.5 micro inch for the first harmonic, and 1.6 micro inch for the second harmonic, at right

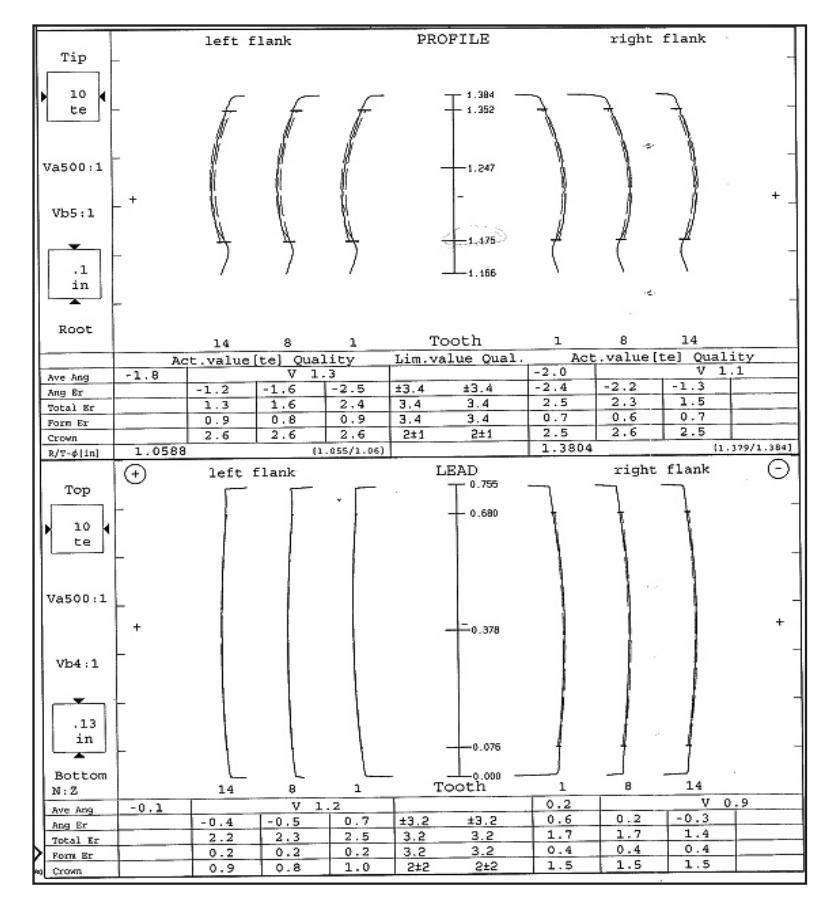
Fig. 11: Original 24T pinion lead and profile chart.

Once the design is proven out we can purchase the high accuracy production workholding and threaded wheels that will allow us to automate our gear grinding process. This in turn keeps our part cost low while maintaining high quality throughout. Figure 11 is an example of the elemental inspection of our lead and profile gear quality chart from one of the prototype pinions.

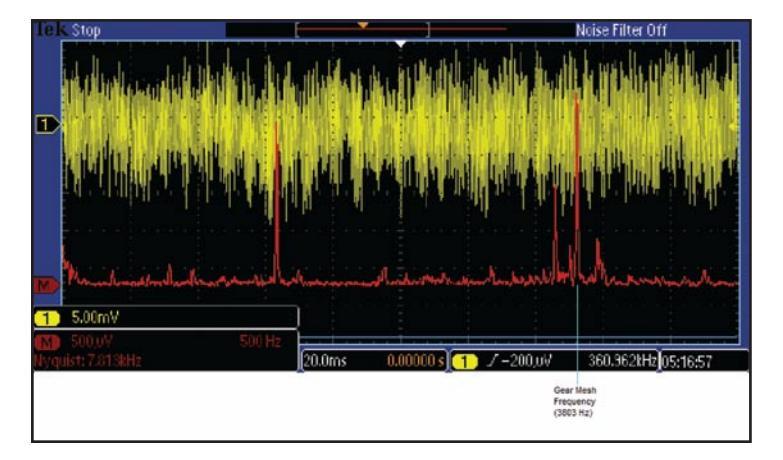
Fig. 12: Noise signal in yellow, and FFT in red of that signal.

changed. Figure 14 shows an FFT (Fast Fourier Transformation) graph (in red) of the original production gear set, showing the gear mesh frequency at 3803 Hz. There are also "side bands" to the left and right of the gear mesh frequency. The other high peak is the compressor rotor frequency. In this test the gear mesh frequency was higher than the compressor rotor amplitude, and you could detect the gear whine.

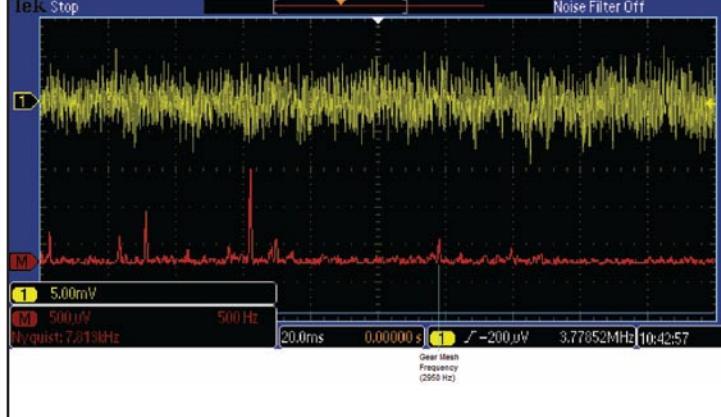
Fig. 13: Noise signal in yellow, and FFT in red of that signal.

Figure 13 also shows an FFT graph of an ODG gear set showing the gear mesh frequency at 2950 Hz. The higher peak to the left is the compressor rotor frequency, which is much higher than the gear mesh frequency. In this test you could not pick out or hear gear whine. Both tests where performed around the same pinion rpm, with the original gear set at approximately 9507 rpm and the ODG gear set at 9316 rpm.
